The mission in photos

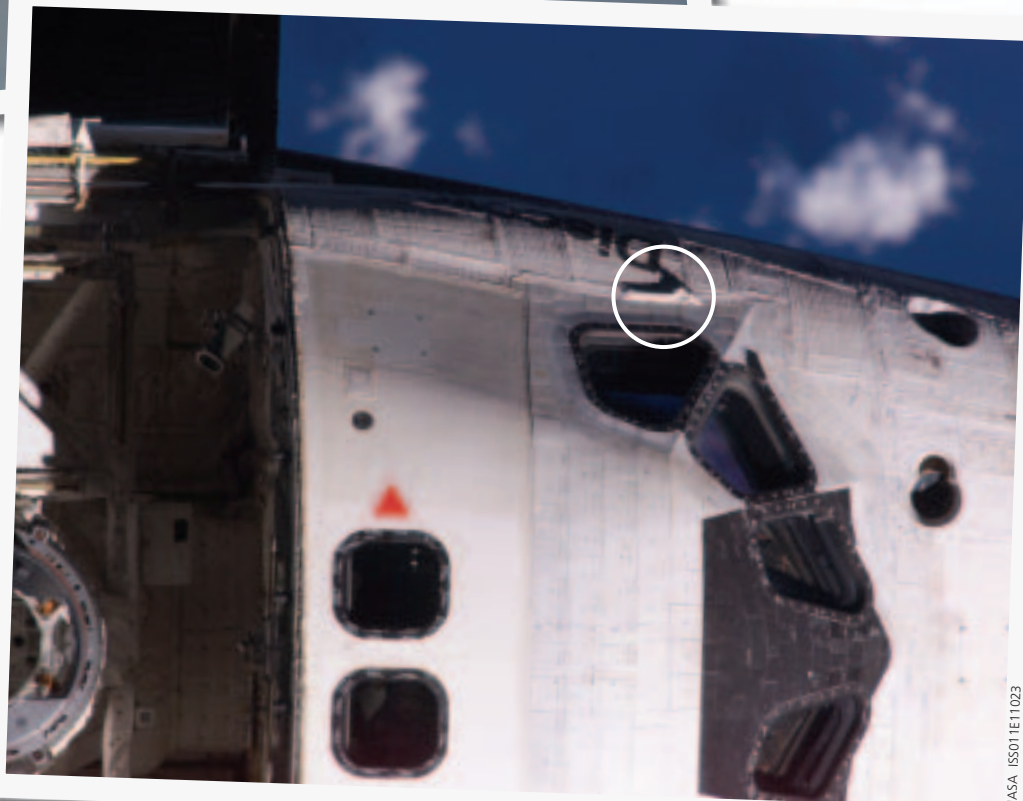
View of the Space Shuttle Discovery's crew cabin and the Orbiter Docking System, photographed as part of the survey sequence performed by the Expedition 11 crew during the STS-114 R-Bar Pitch Maneuver on Flight Day 3. A raised area of thermal blanket material (circled at right) can be seen just below a window on the commander's (port) side of the cabin.

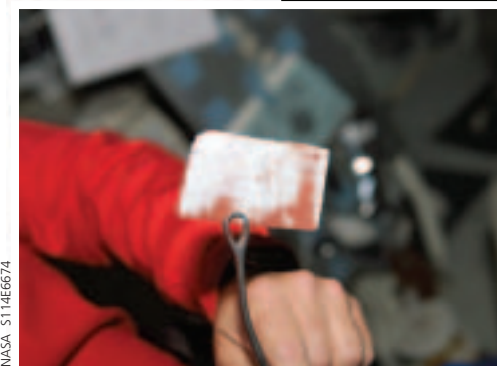
One of the STS-114 crew members holds a piece of the gap filler material (inset), which had been protruding from between Thermal Protection

System tiles and which was retrieved during the third spacewalk of the flight by Mission Specialist Steve Robinson. Robinson (above) used his gloved fingers to pull out this gap filler and another one from Discovery's belly while carefully supported and maneuvered by the Canadian-built remote manipulator system, operated inside Discovery's cabin by astronauts Wendy Lawrence and Jim Kelly.
